KNIGHT'S COURT, TEMPLETON, PEMBROKESHIRE
SUMMARY OF ARCHAEOLOGICAL WORKS COMPLETED AS PART OF ORIGINAL –
PLANNING PERMISSION BY DAT ARCHAEOLOGICAL SERVICES

1 INTRODUCTION

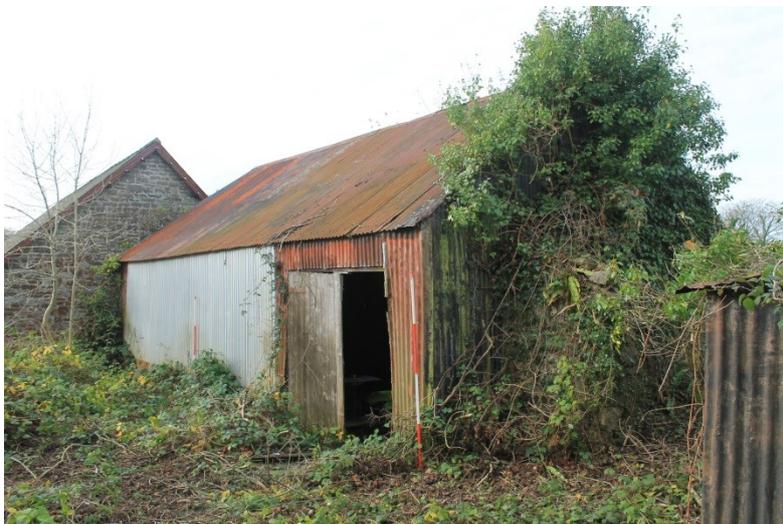
Photo 1: View southwest across eastern façade of former barn

- 2.1 Building recording was undertaken on the former barn on the street frontage on 31st October 2014. The works included a photographic survey of the structure, hand drawn plans / elevations and a written description (Photos 1 & 2; Figure 1).

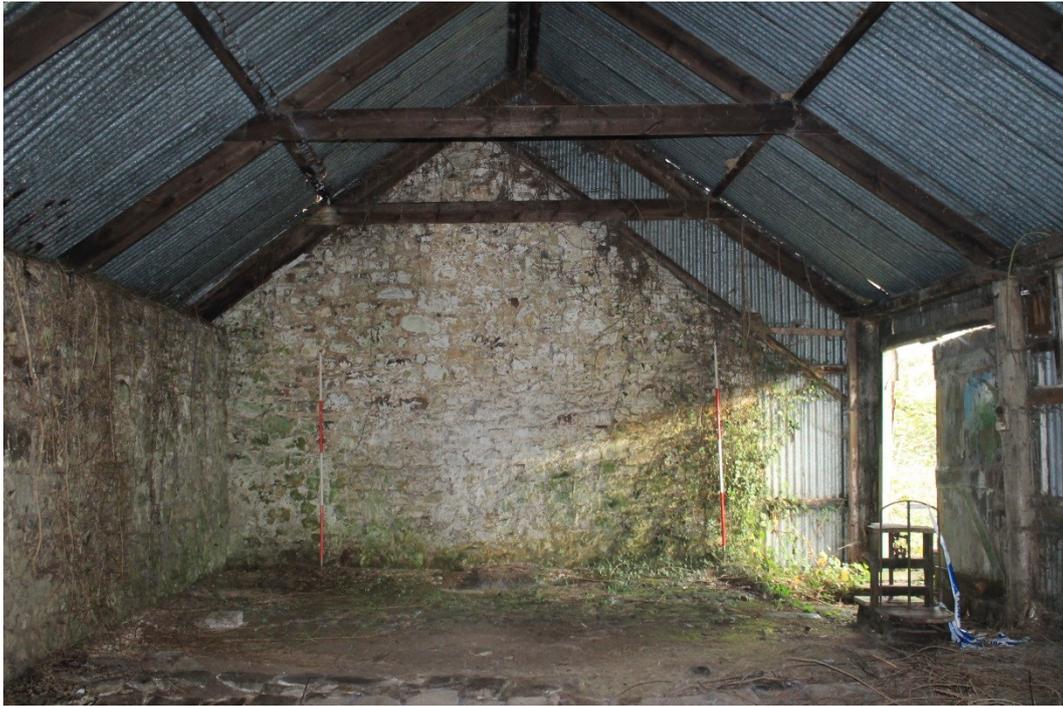
Photo 2: Internal view of northern gable end of barn

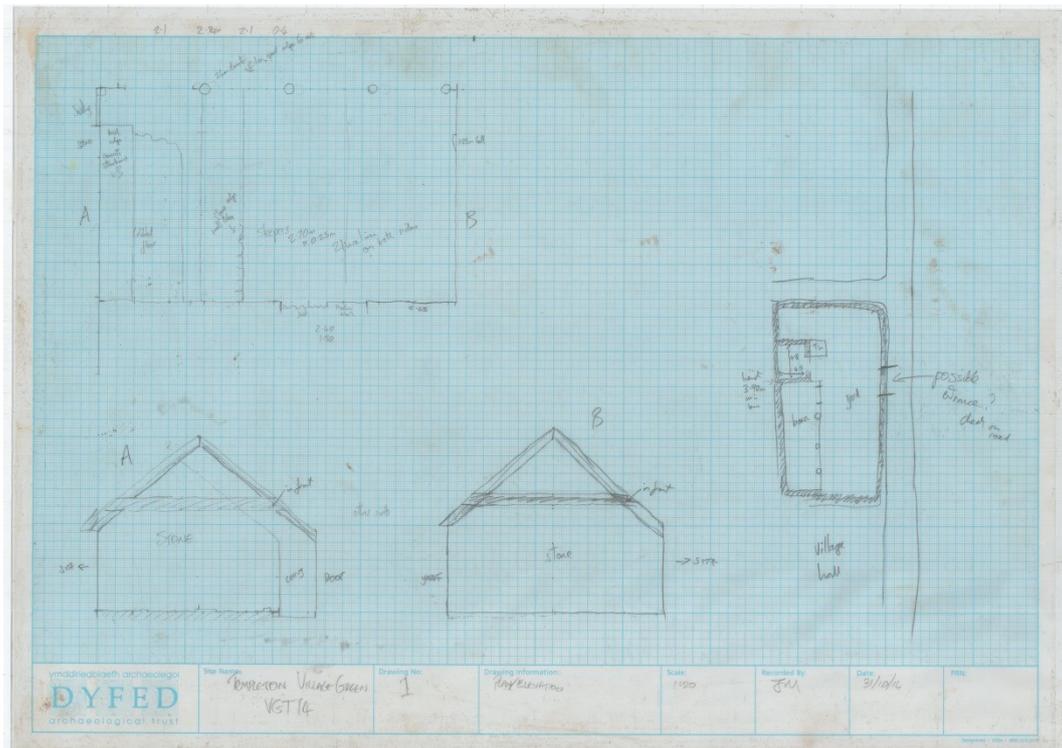
Figure 1: Elevations, floor plan and sketch layout plan of former barn

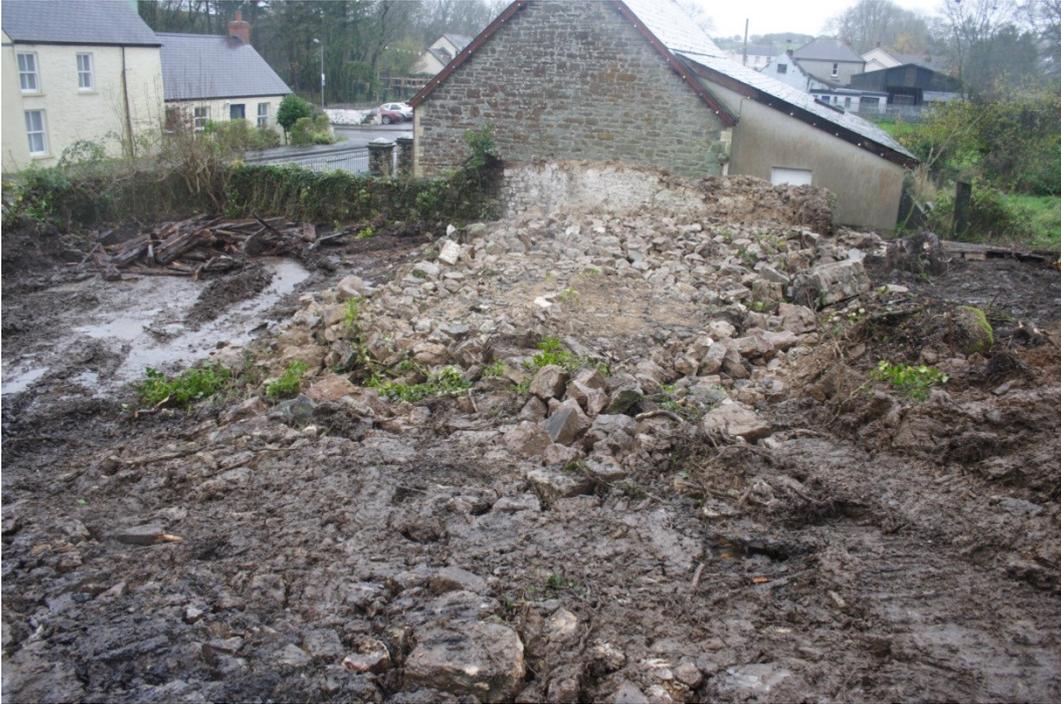
Photo 3: View southeast across site of former barn following demolition (13/11/2014)

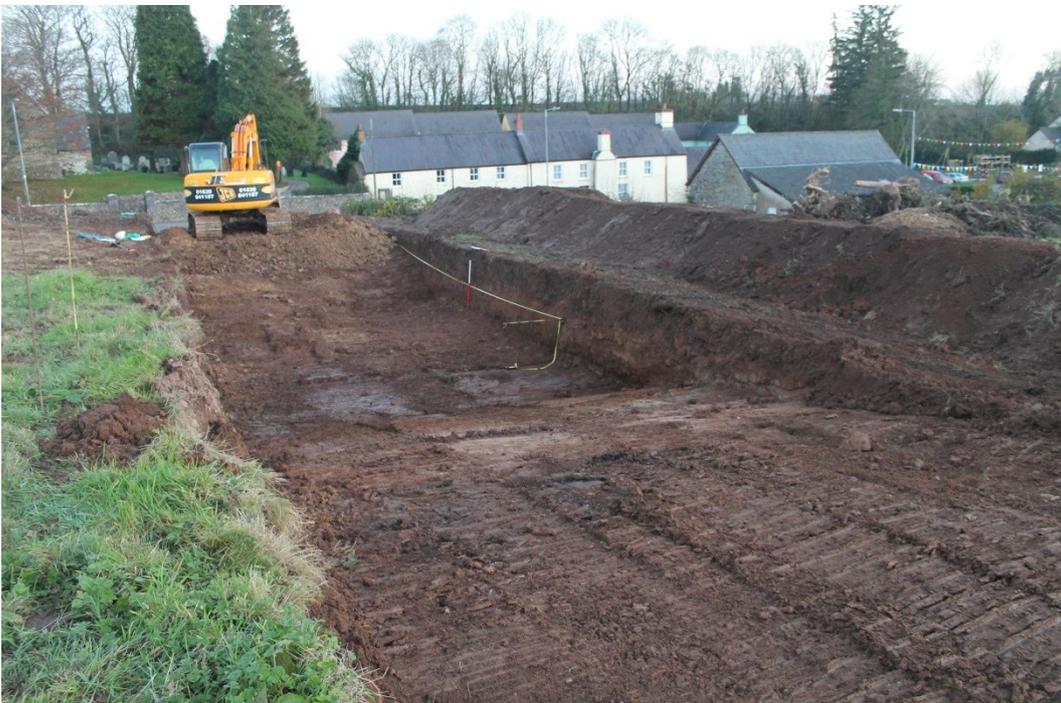
Photo 4: View southeast across eastern part of access road (18/11/2014)

included observation of groundworks, hand drawn sections and plans of archaeological features revealed, written descriptions and photographic record (Photos 4, 5 & 6).

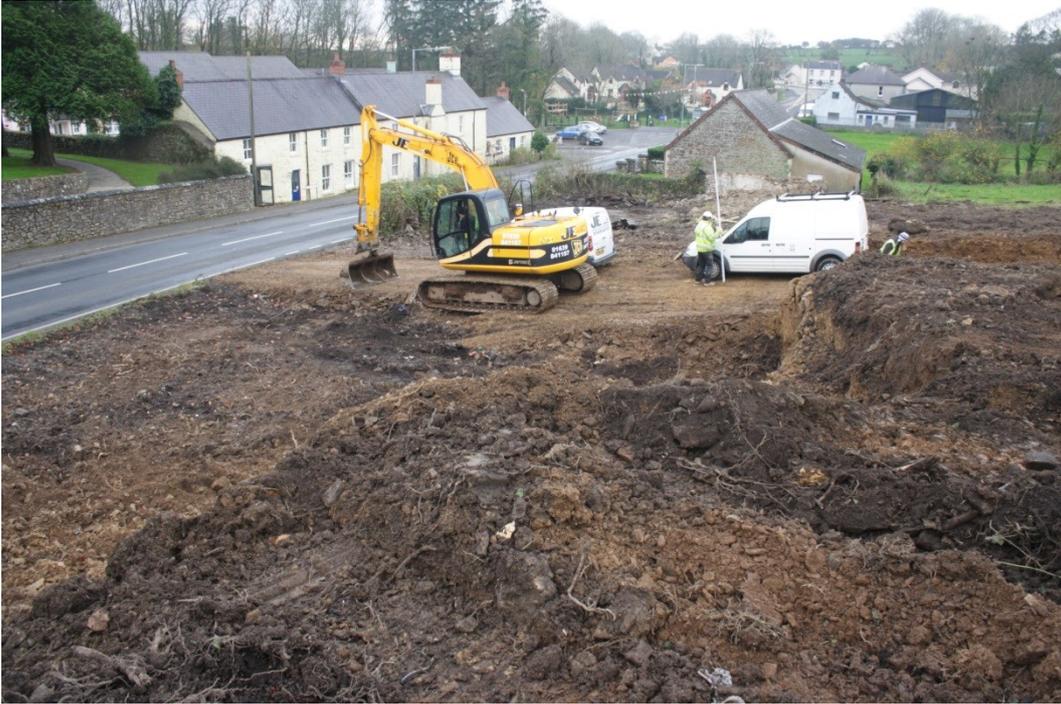
Photo 5: View south across area of eastern frontage buildings during ground reduction (19/11/2014)

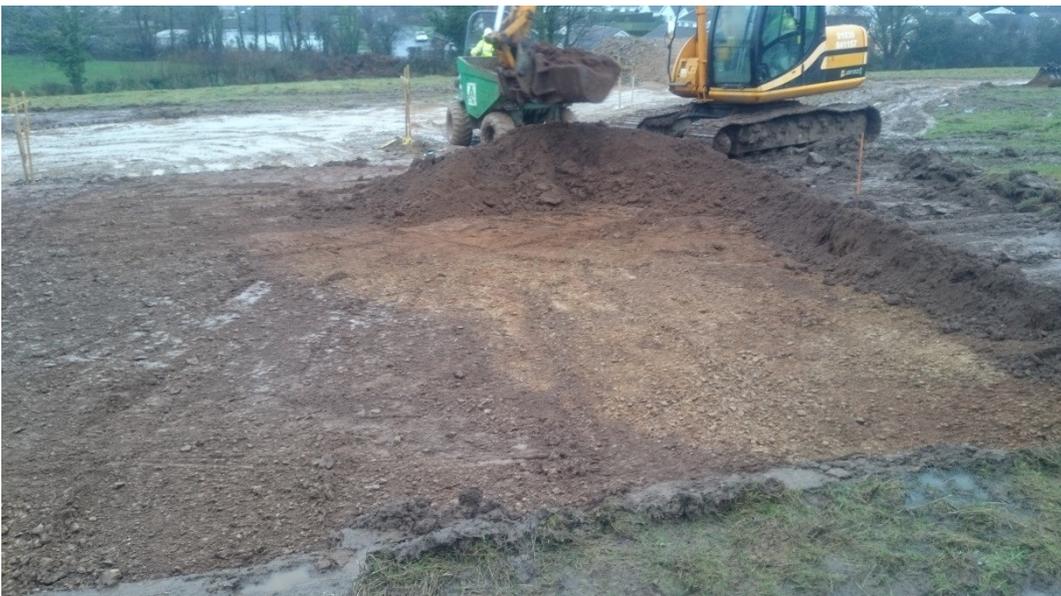
Photo 6: Machine stripping of western edge (darker material) of large medieval ditch

- 2.4 House Plot 5 was located on the projected line of the large medieval boundary ditch running north to south discovered during the evaluation undertaken in 2010. This area was subject to excavation between 12th and 20th of January, 2015. Initially the area was machine stripped with a graded bucket to the correct archaeological level before being hand cleaned to delineate it for recording prior to excavating two trenches through it (Photo 6).

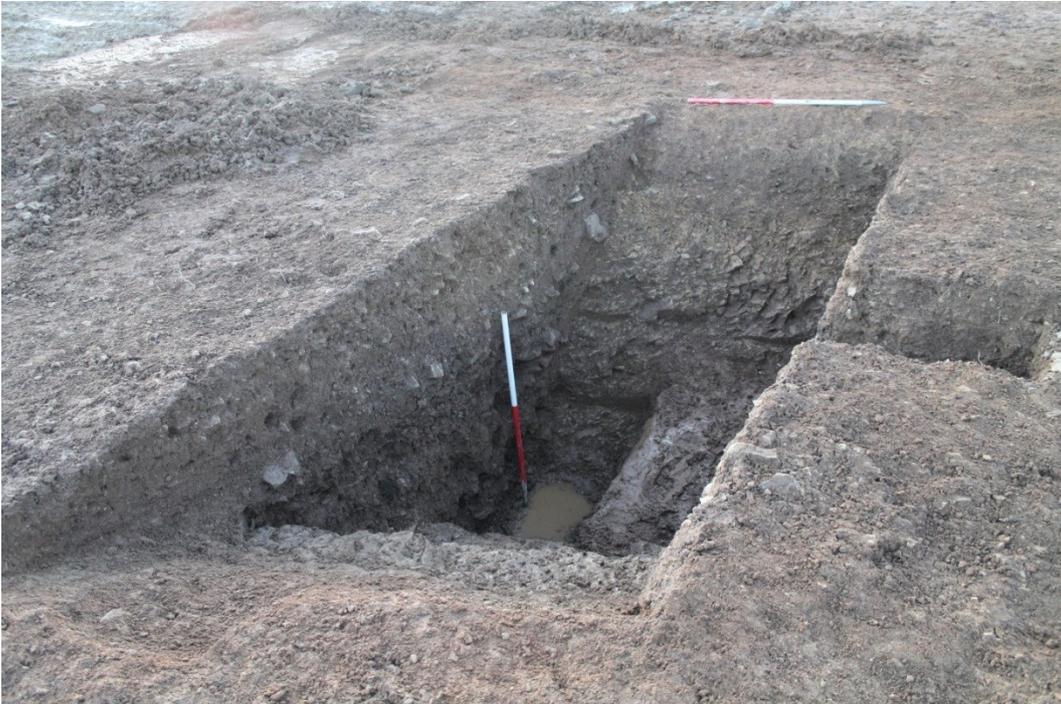
Photo 7: View south west of trench 1 with north facing section visible

Recording Manual¹ and recorded by archaeological recording context sheets. All artefacts were securely located and retrieved from the ditch. Due to difficult working conditions it was decided to excavate Trench 2 with a machine using a graded bucket. Exposed sections of the ditch were recorded by means of measured drawings (Figures 2 & 3) and a photographic record was maintained using a digital camera Photos 7, 8 & 9).

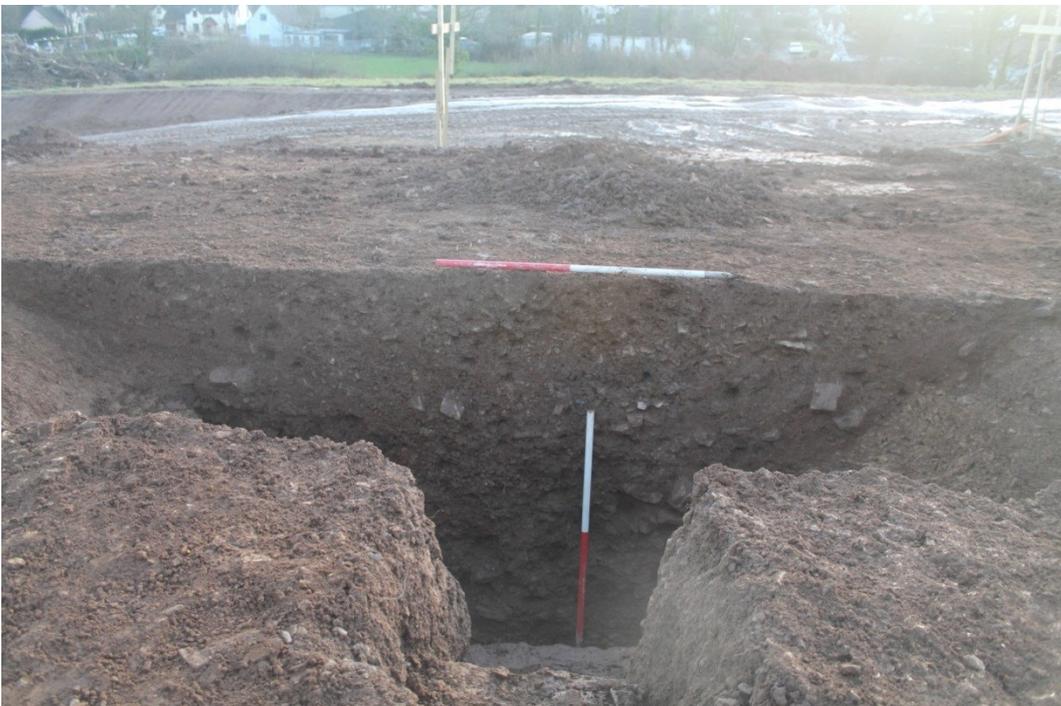
Photo 8: North facing section of Trench 1 through ditch

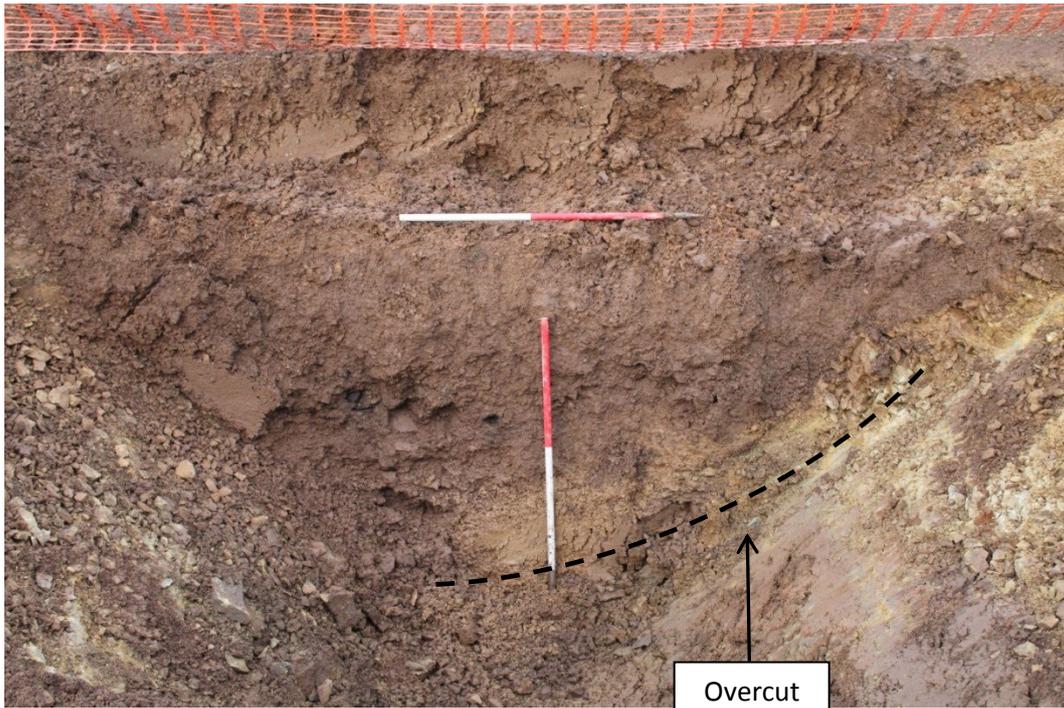
Photo 9: South facing section of Trench 2 after machine excavation through ditch

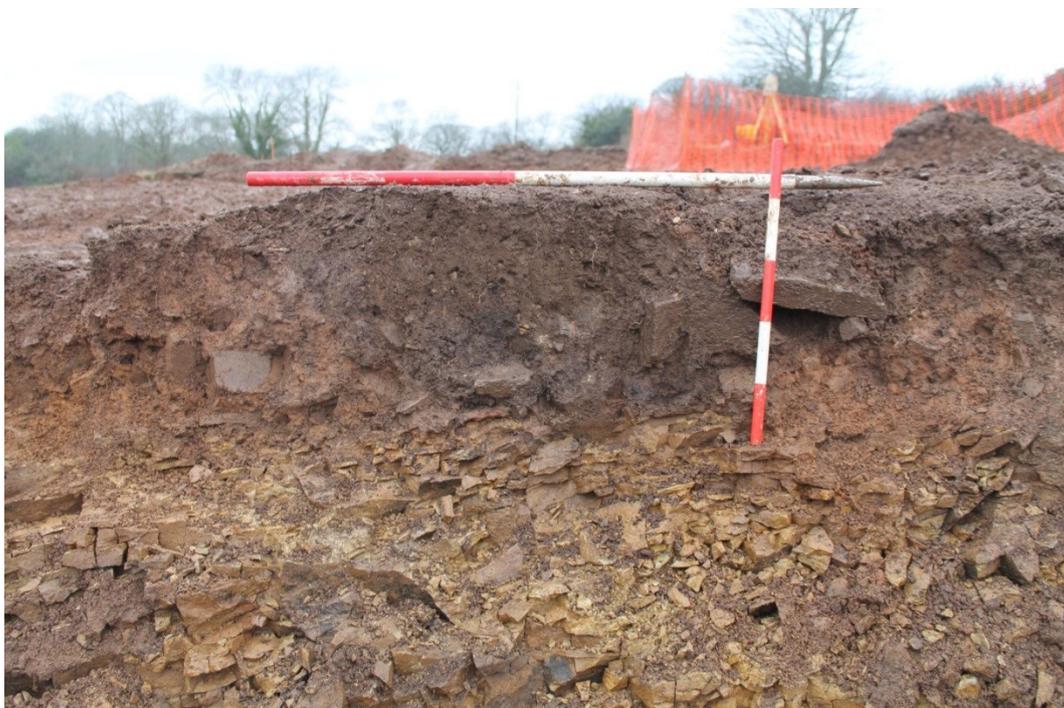
Photo 10: Feature 109 as visible in east facing section.

2.6 Other features were also identified in the area to the east of the medieval ditch (Photos 10 & 11).

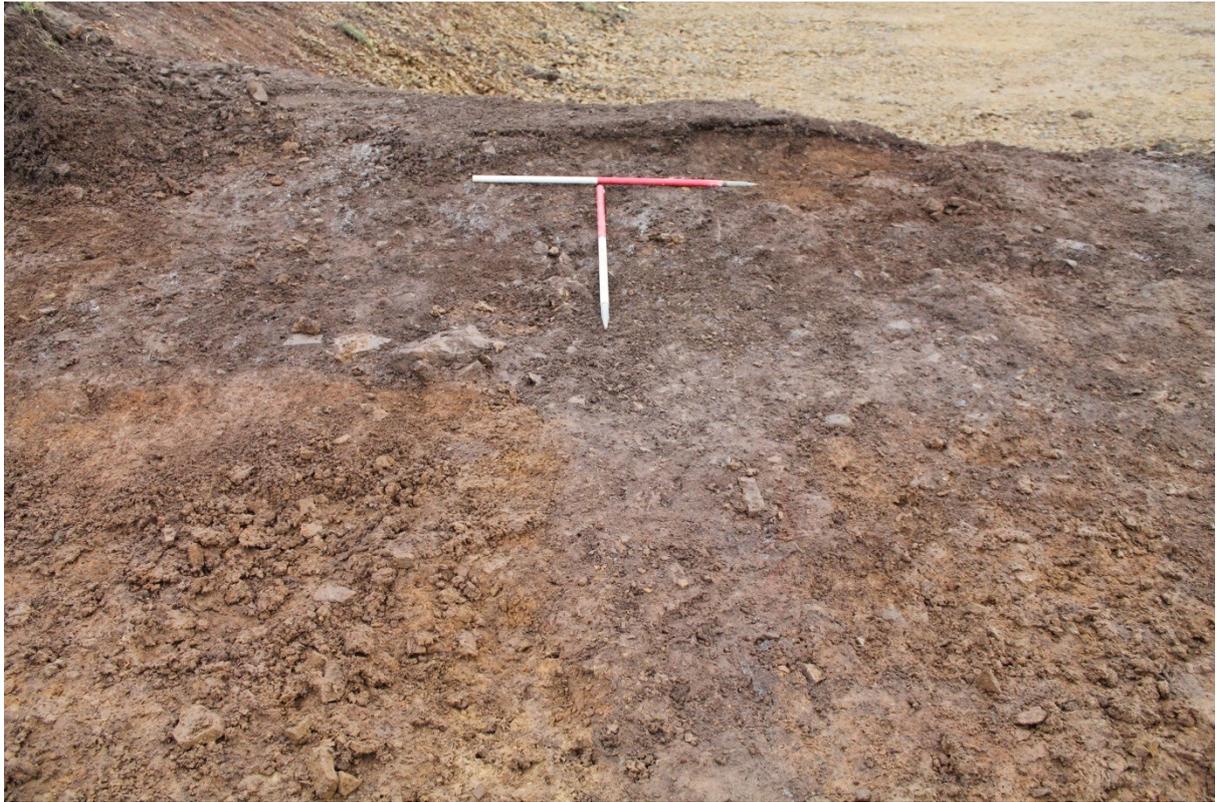
Photo 11: Area of features to east of the medieval ditch facing east

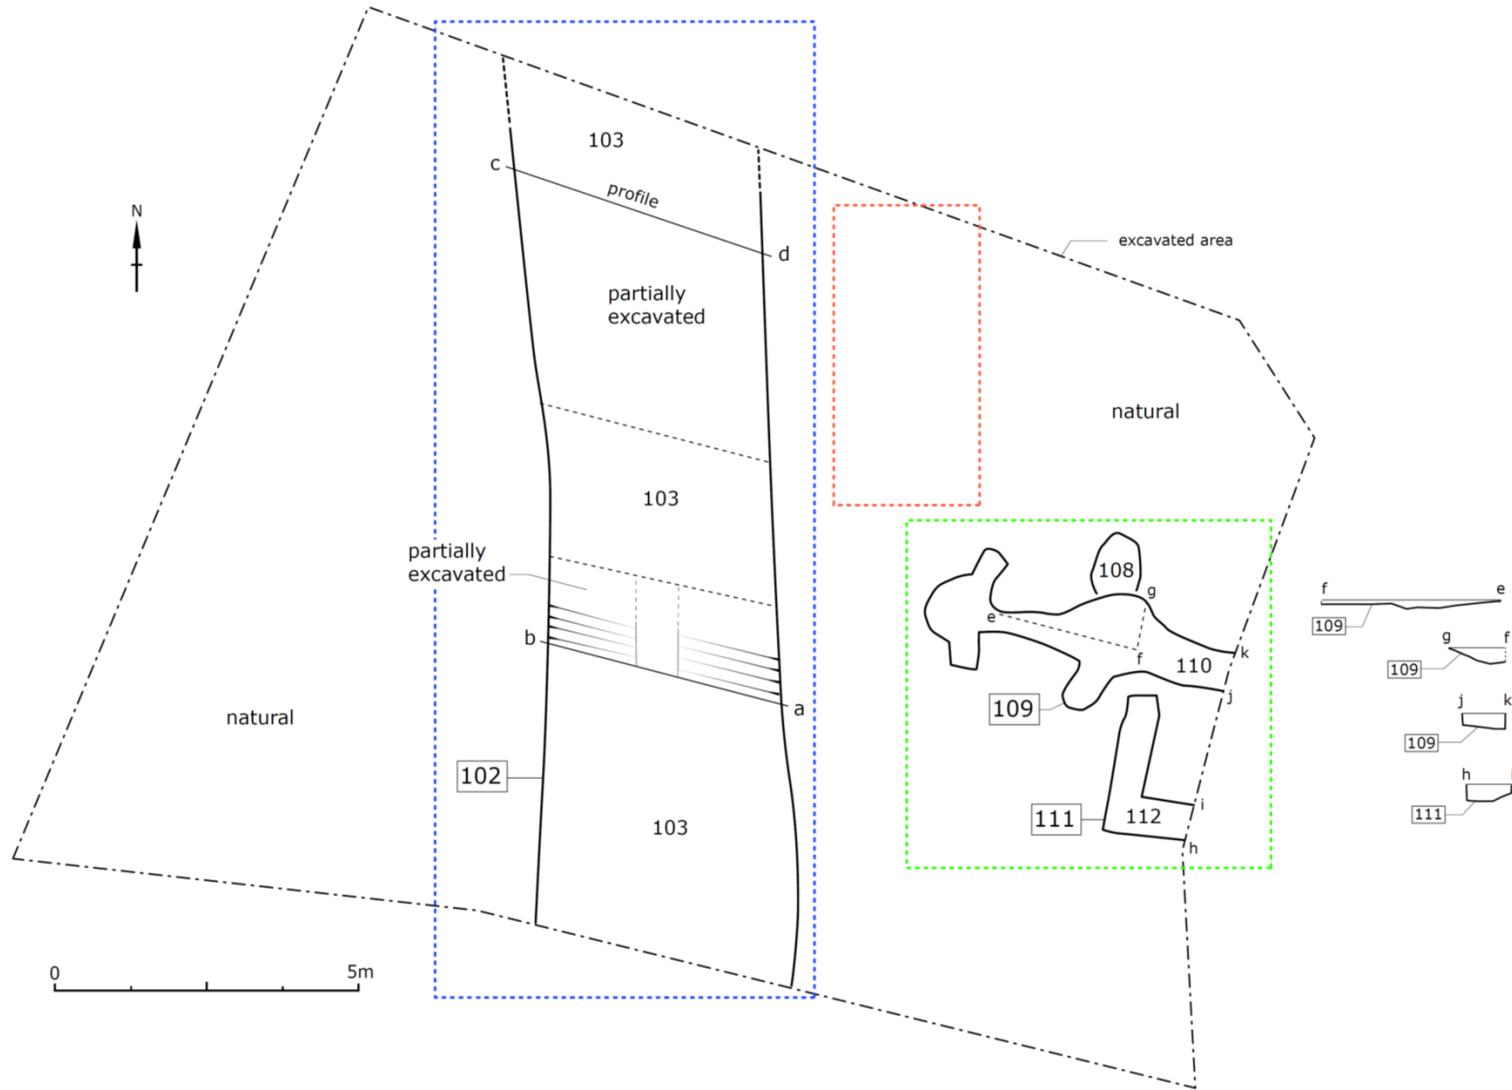
Figure 2: Plan of Excavation Area showing medieval ditch and features to the east

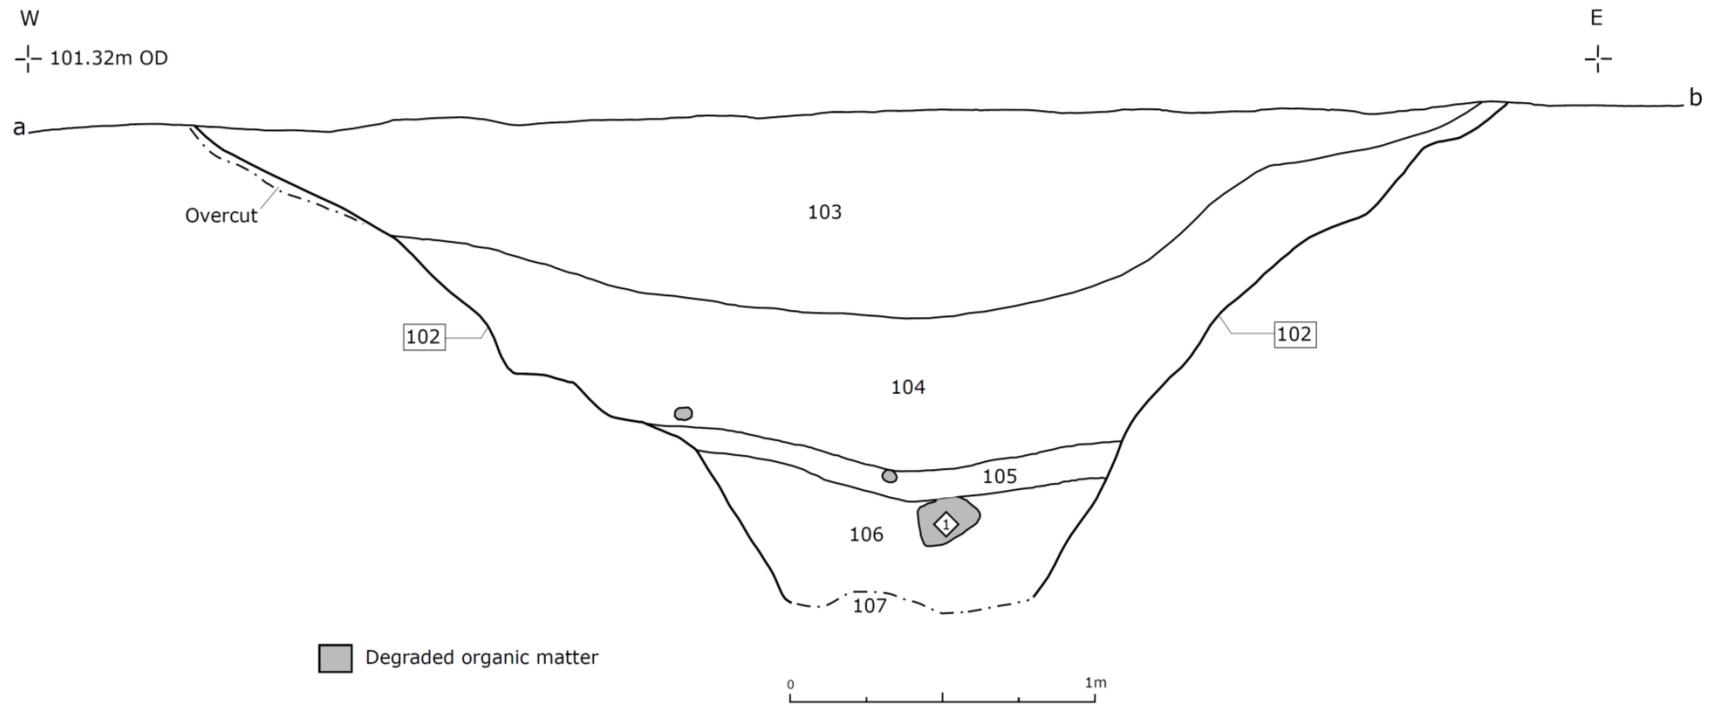
Figure 3: North facing Section of Trench 1, Ditch
